CRCP CONCRETE REPAIR PROJECT -A2 BOUGHTON BYPASS PHASE ONE & TWO

LMS Highways deliver CRCP and various other carriageway repairs to the A2, Boughton Bypass in multi phase programme.

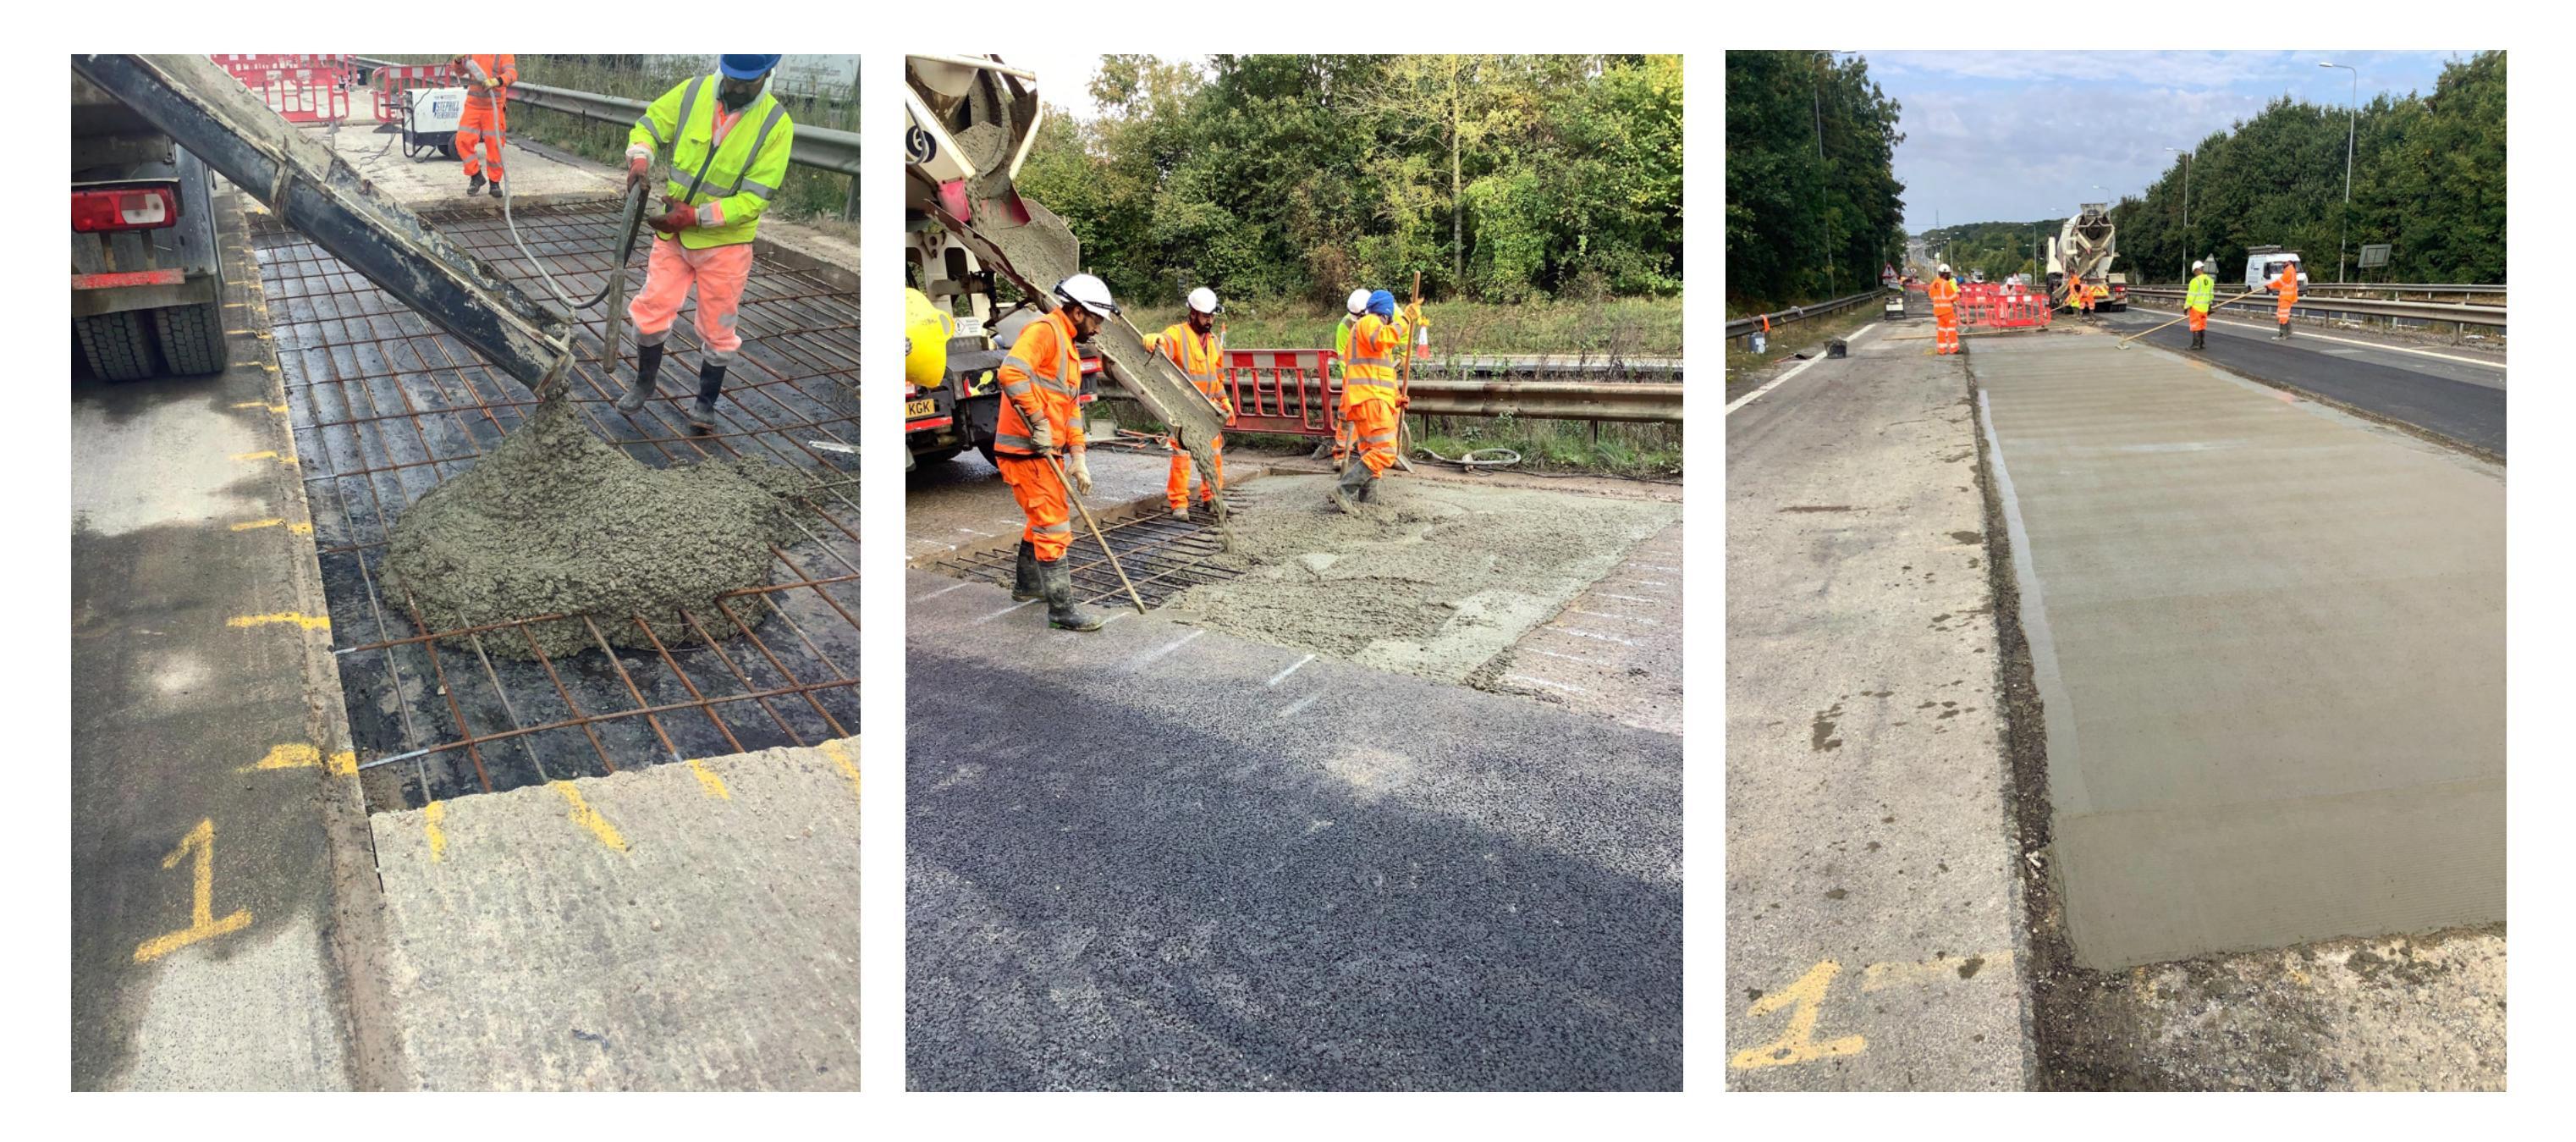
During phase two of this project we were occasionally faced with severe weather conditions causing flooding throughout the site. This poses an issue as it prevents the concrete from being installed and in turn would delay the entire program schedule. For large scale projects such as these our team spends weeks meticulous planning and choreographing every aspect to ensure it's delivered on time, on budget and with little to no disruption.

This prior planning ensures when we are faced with issues such as flooding, our teams have the measures in place to overcome and continue on with the project safely. Multiple water pumps were deployed to remove resting water from the bays and sandbag dams were placed to redirect the flowing water away from are working area.
